SCIENTIFIC INVESTIGATION REPORT

Jacob Sean Barben v. Federal Cartridge Company et al.

Ct. Case No.: 1:16-CV-00094-DN
Rep./Ins.: Federal Cartridge Company
Loss Location: Bear River Pheasant Hunting Grounds, Elwood, Utah
Date of Loss: October 30, 2014
AEI Project No.: 13131

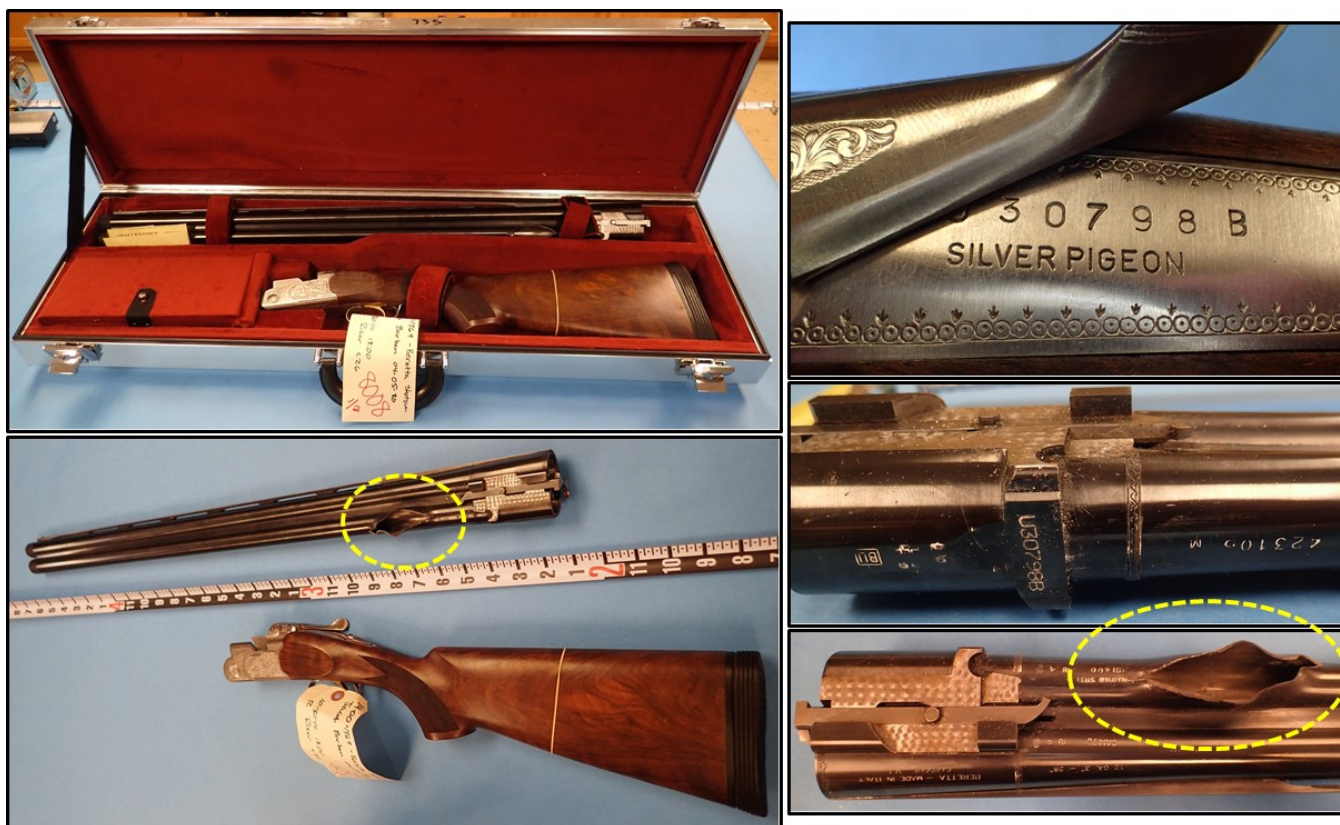
Figure 1. The subject shotgun as delivered by Jessica Andrew (of Lance Andrew, P.C., Plaintiff's counsel) for the joint destructive examination held at AEI on February 6, 2017, with the apparent lower barrel burst highlighted by the yellow dashed ellipses (CW from top-left: 13131 SAS 2-002, 13131 SAS 2-025, 13131 SAS 2-046, 13131 SAS 2-057, and 13131 SAS 2-009).

Figure 2 shows photos of the apparent lower barrel burst zone that started visibly from about the 9 O’clock position at 4.2” and ran to the 7-8 O’clock position at 7.1” for a total fracture length of ~2.9”. The widest separation of the burst zone fractures was just under 1” and was located at ~5.8”, near the mid-point of the fracture length. The left photo in Figure 2 shows a yellow arrow to indicate an apparent circumferential ring bulge centered at ~4.9”, located within the upstream end of the burst zone.

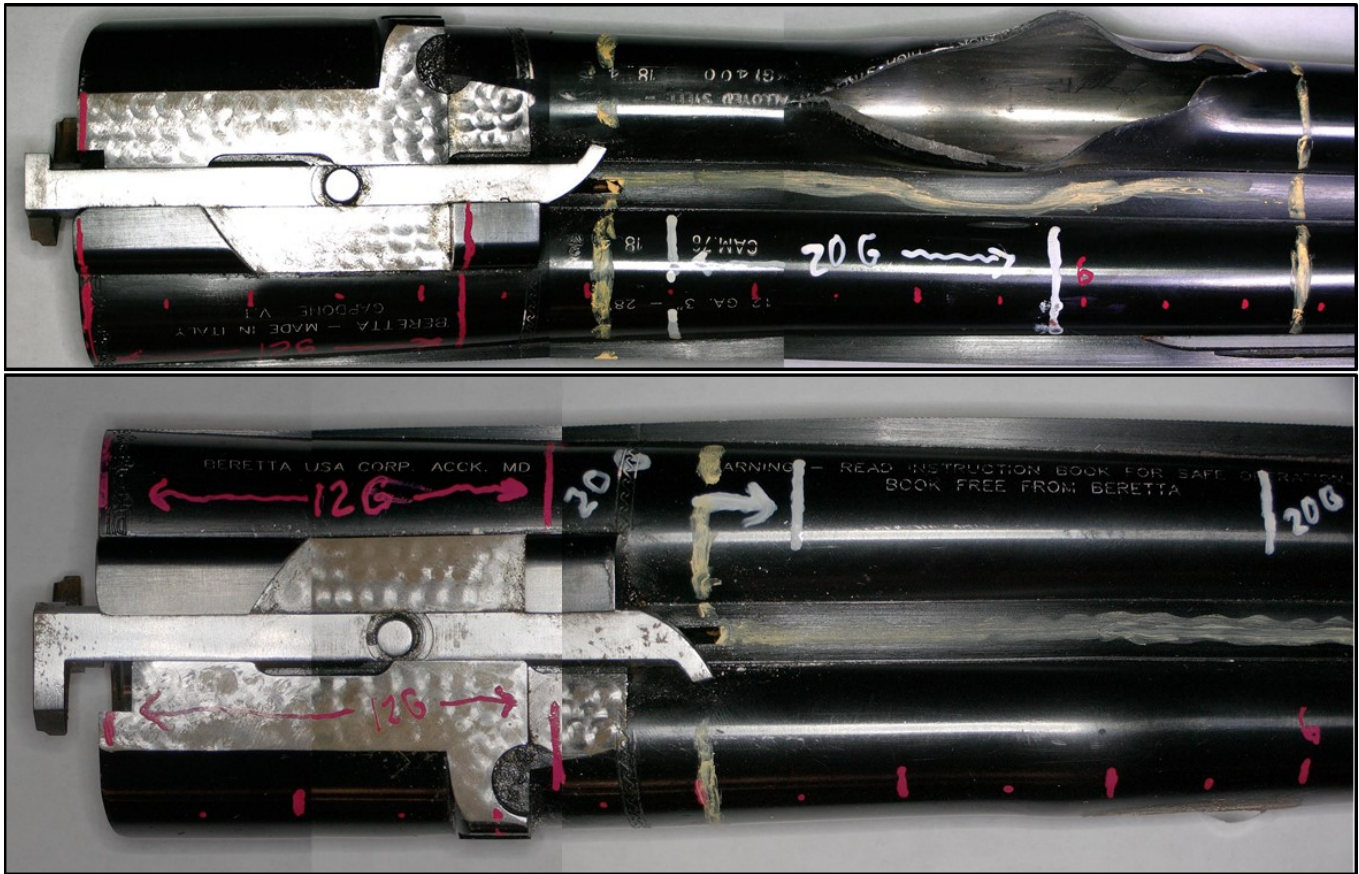
Figure 8 shows two composited (stitched), wide-angle microscopy images of each side of the marked up, breech end of the subject barrel assembly. The artifact is shown with 1) half-inch hash marks in red, 2) the extent of the 12G, 2 $\frac{3}{4}$ " shotshell also in red, 3) the insertion depth and length of a 20G, 2 $\frac{3}{4}$ " shotshell marked in white, and 4) the proposed sectioning locations marked in yellow. As discussed above, the sectioning locations were selected so as to preserve as much physical evidence within the barrel as possible while minimizing the number of cuts that needed to be made, and minimizing the overall physical size of the resulting sections. Minimizing the number of cuts and the size of the sectioned pieces is a standard goal in a destructive examination as it generates less disturbance of the physical evidence and allows for a wider range of instrumental analysis methods to be used, since most surface analysis methods have limitations on the physical size of samples (*e.g.*, FTIR microscopy and SEM/EDS).

Figure 8. Compositd Keyence microscope images showing the overall registration and sectioning markup of the breech-end of both sides of the subject fore-end barrel assembly prior to beginning the destructive sectioning and analysis. The red paint marks indicated every half inch along the barrel length and the location of a 12G, 2³/₄" shell in the upper barrel chamber, the white paint marks indicated the depth and length of a 20G, 2³/₄" shell, and the yellow paint marks indicated the intended sectioning/cutting locations.

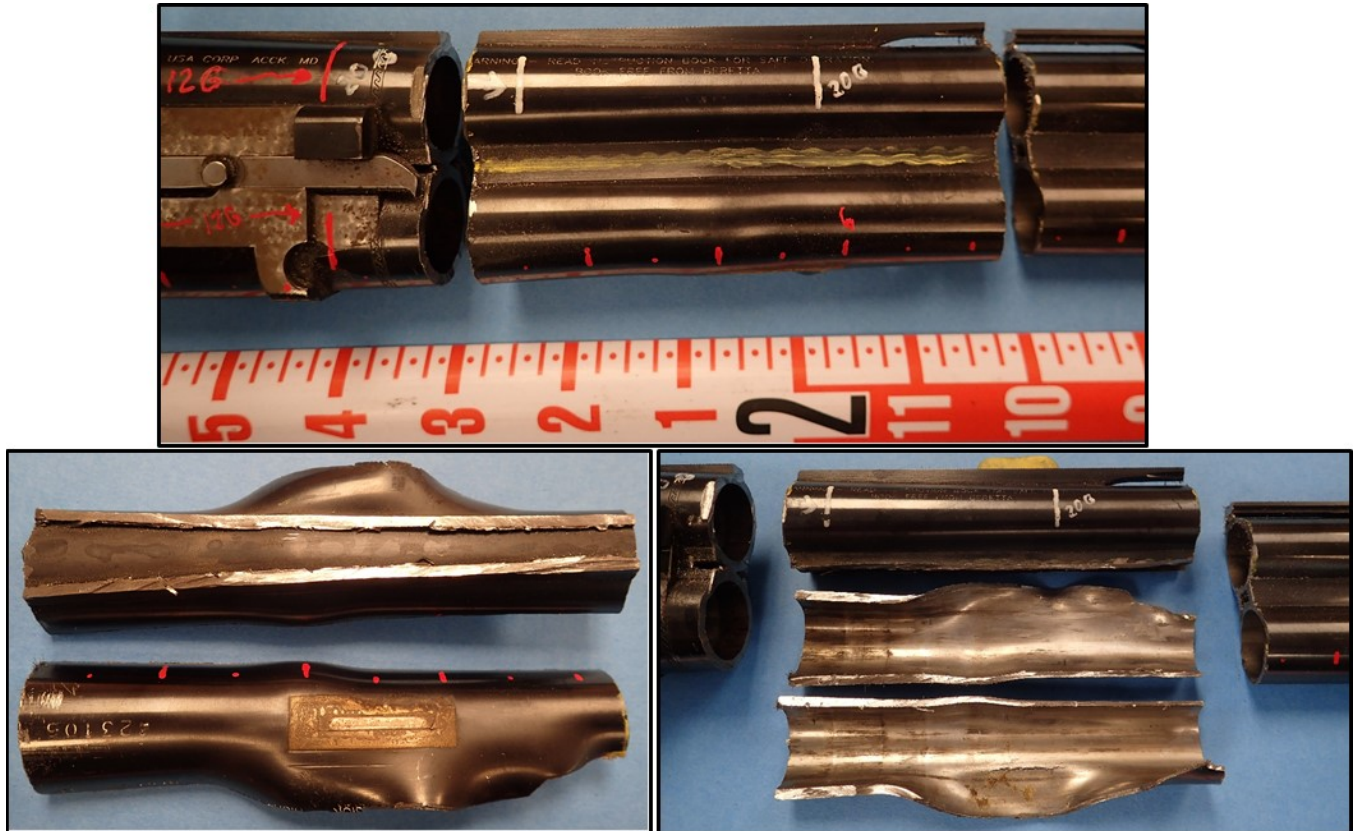
After briefly discussing the rationale for the sectioning marks, the parties present agreed verbally to proceed into the destructive phase of the examination in which the two transverse cuts were made through both the upper and lower barrel tubes as shown in the top photo of Figure 9. These cuts were made using a combination of a tungsten carbide-gritted handsaw blade and a 100-grit, diamond jeweler's wire saw blade. Hand tools were used for these cuts to prevent the buildup of excessive heat that could result from a band saw, reciprocating saw, or spinning wheel cutting tool. Once the two transverse cuts were made and documented, the resulting lower barrel section spanned the lengths from 3.1" to 7.3" as originally measured from the breech end of the barrel assembly. The next two longitudinal or "spine" cuts were made along each of the connecting rib sections to separate the upper barrel from the lower barrel as can be seen on the upper section of the lower left photo in Figure 9. These spine cuts were made with a small abrasive cutting disk using a rotary, Dremel-style tool since the connecting ribs sections were relatively thin and would not buildup excessive heat within the barrel tubes during cutting. The final "butterfly" cuts were made with the diamond-wire jeweler's saw and roughly bisected the lower barrel tube with the first longitudinal cut made along the 3 O'clock position, and then the remaining "tendons" of metal were severed to within ~1/4" of the

Figure 9. Photos depicting the sectioning sequence to prepare and preserve the regions of interest for further inspection and testing, including the ring bulge, burst zone fracture surfaces, and additional powdery deposits and physical markings just upstream of the burst zone within the lower barrel ID surfaces (CW from top: 13131 SAS 2-300, 13131 SAS 2-347, and 13131 SAS 2-353).

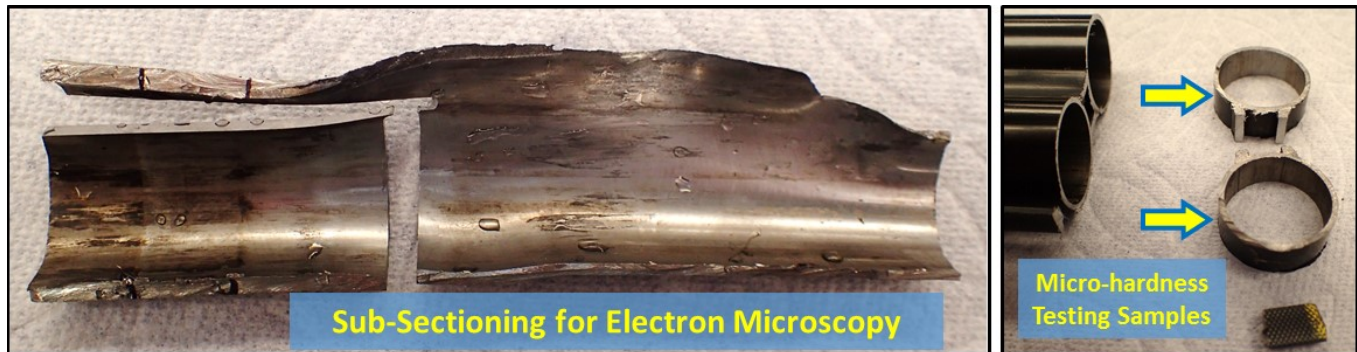
The right photo in Figure 14 shows the barrel tube sections that were removed from the upstream end of the remaining length of the barrel assembly from ~7.5” to 8.0”. These barrel sections were then prepared for micro-hardness testing by embedding them in heat-activated resin made for this purpose. The resulting

“hot metallurgical mounts” were then polished using a series of finer grit polishing wheels to obtain a mirror finish on the barrel tube metal surface where the micro-hardness test instrument was used to make a series of indentations at three circumferential locations while measuring the force and the resulting indentation size. From these three measurements on each tube, the averaged micro-hardness values for a 0.5 kg load was 282 HV for the top barrel and 290 HV for the lower barrel; these micro-hardness values correspond to Rockwell C hardness values of 26 and 27 for the upper and lower barrel tubes, respectively.

Figure 14. On the second day of the joint destructive shotgun exam, the lower barrel section had to be sub-sectioned to the smaller region at lower left in the left photo to fit into the SEM/EDS sample vacuum chamber, and the barrel tube region from ~7.5” to ~8.0” was cut, the upper and lower tubes were separated, hot mounted, polished, and measured for micro-hardness (13131 SAS 3-030 and 13131 SAS 3-022).

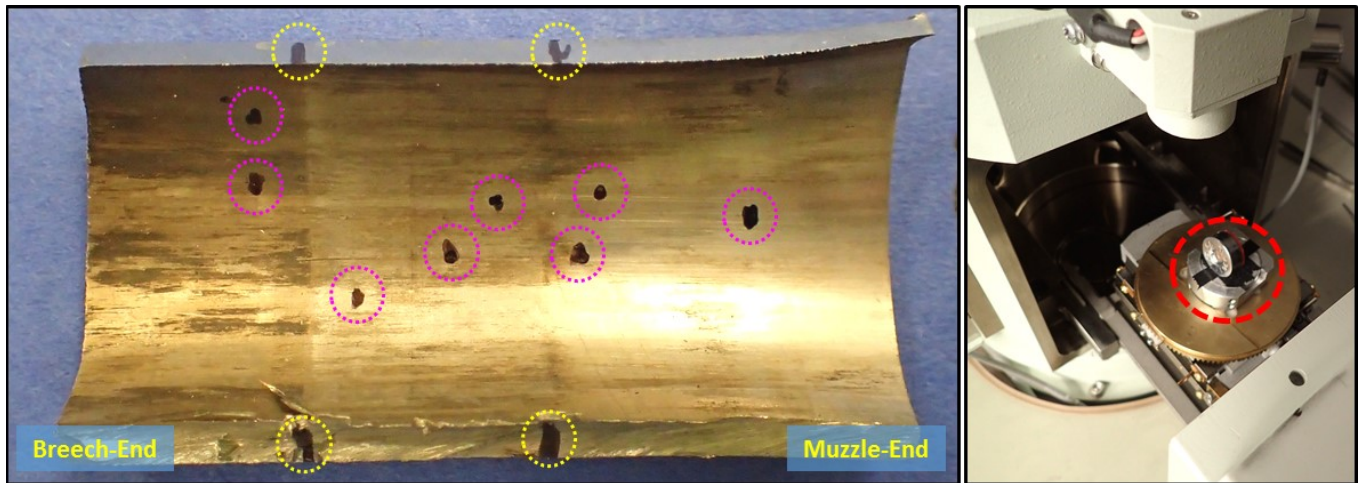
Figure 15. Photo of the lower barrel SEM section with added Sharpie® marker spots (left photo, yellow and pink dashed circles) for indexing and navigation within the SEM sample chamber (right photo) during imaging and EDS testing (13131 SAS 3-035 and 13131 SAS 3-007).

In the left photo of Figure 15, the yellow dashed ellipses highlight the two sets of hash marks for identifying the coloration/residue bands at 3.54" and 4.04", and the pink dashed circles represent navigation points placed near where there was an interest to inspect, image or analyze the ID barrel surface or residues. The main goal of this effort was: 1) to examine the region between 3.54" and 4.04" to identify the presence or absence of witness marks and scratches, 2) to examine a relatively clean portion of the ID surface to identify whether or not the surface was chromium plated or lined, 3) to identify the elemental composition of the dark gray-brown powdery residues, and 4) to identify the presence and location of any zinc, iron, nickel, or copper on the barrel surface that might indicate the prior presence of a 20G barrel obstruction.

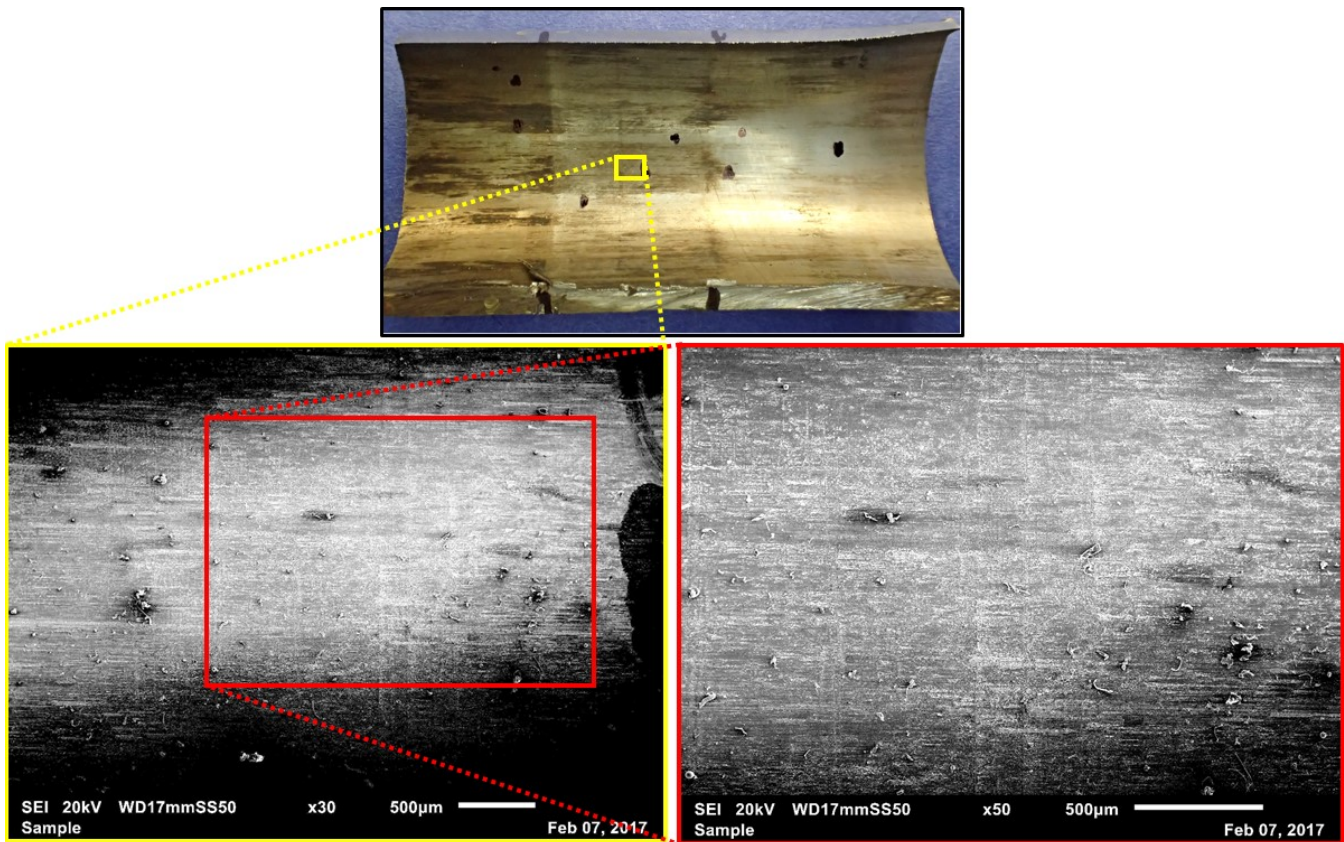
The top photo in Figure 16 is provided as a visual reference to indicate where these SEM images were obtained (see yellow inset rectangle), and in this case the goal was to capture a number of images at varying magnifications to identify the circumferential witness marks (vertical lines visible in both lower SEM images of Figure 16) and the longitudinal streaking that had been seen in optical microscopy, but were difficult to capture in the static images.

Figure 16. Index photo of the lower barrel section (top, 13131 SAS 3-038) with the inset yellow rectangle corresponding to the SEM image location at lower left, with inset red rectangle corresponding to the SEM image location at lower right showing detailed images of the circumferential scratches (vertical witness marks) and longitudinal streaking of the barrel deposits (horizontal banding).

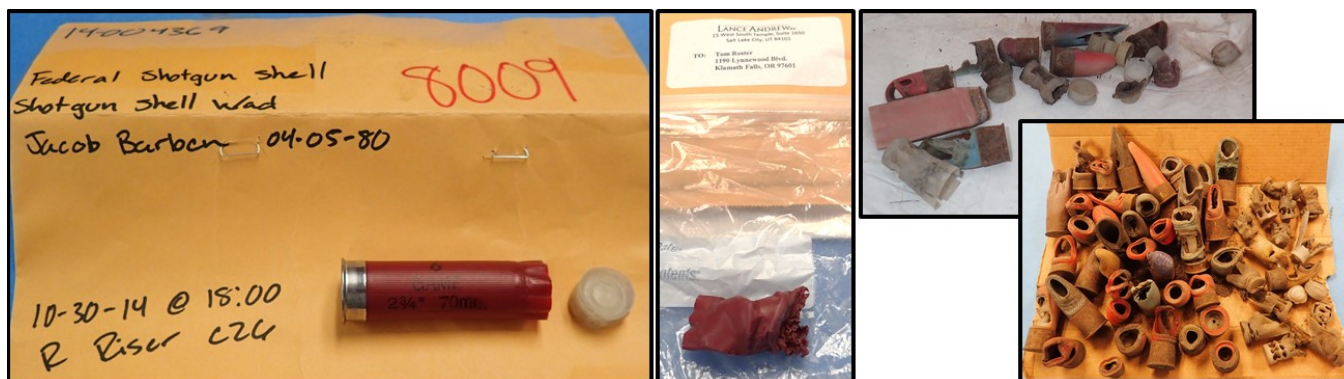
Figure 22. Photos of the “8009” hull artifact as received and examined on June 14, 2017 (13131 SAS 4-021, 13131 SAS 4-024, 13131 SAS 4-029, and 13131 SAS 4-047).

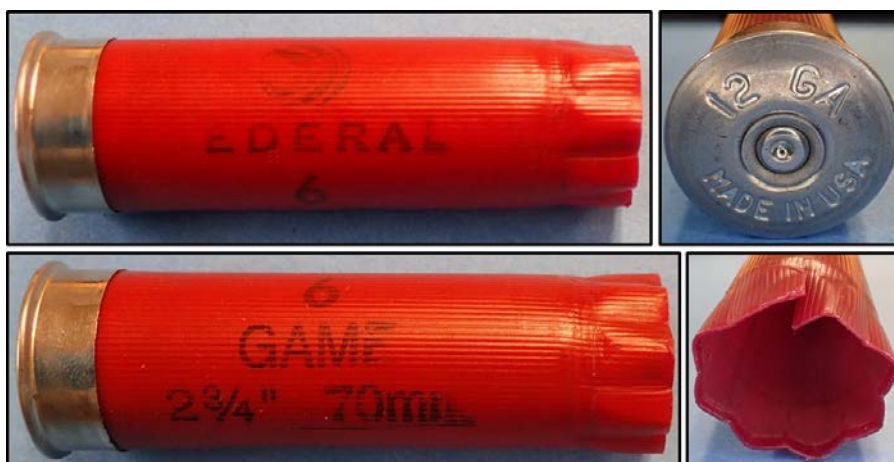
Figure 23 show photos of the “8009 spent hull” artifact as received and examined by this writer at AEI. Figure 24 shows similar photos of the “separated hull” artifact as received and examined by this writer. With close visual and microscopic examination under a variety of lighting conditions, the “separated hull” artifact does have printed markings which resemble the markings of a Federal “H121 6” shell.

Figure 23. Photos of the “8009” hull artifact as received and examined on June 14, 2017 (13131 SAS 4-172, 13131 SAS 4-177, 13131 SAS 4-187, and 13131 SAS 4-173).

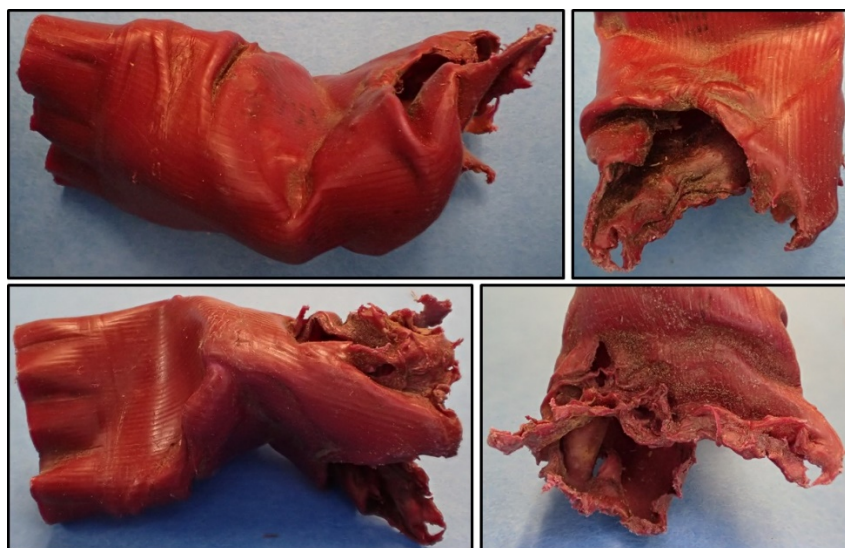
Figure 24. Photos of the separated hull artifact as received and examined on June 14, 2017 (13131 SAS 4-124, 13131 SAS 4-140, 13131 SAS 4-126, and 13131 SAS 4-118).

In Mr. Roster's ammunition report (dated "11-20-2016"; also marked JSB000341-378) he attributed the roughly damaged portion of the "separated hull" artifact that was at the opposite end from the crimp end (see the lower right photo of Figure 24) as having possibly come from the impact of #6 shot pellets. Mr. Roster further claimed that what he termed an "indent", "dimple", or "pit" located at the position in the blue dashed rectangle of Figure 24 was perfectly sized and cupped to fit a #6 shot pellet. During this writer's examination of the "separated hull" artifact, an optical 3D profile was prepared from high-resolution Z-stacking images in the Keyence VHX-5000 microscope, and the rightmost image shows a rotated 3D reconstruction of the artifact "dimple". Given the undocumented nature of where and when this artifact was recovered, there are too many possibilities for this writer to consider on how this artifact could have lost its metal head, become kinked, damaged, deformed, and wrinkled.
